Report on earthquake-induced failures of rural buildings aimed at future preservation strategies

Marco Bovo, Alberto Barbaresi, Daniele Torreggiani, Patrizia Tassinari

Department of Agricultural and Food Sciences, University of Bologna, Italy

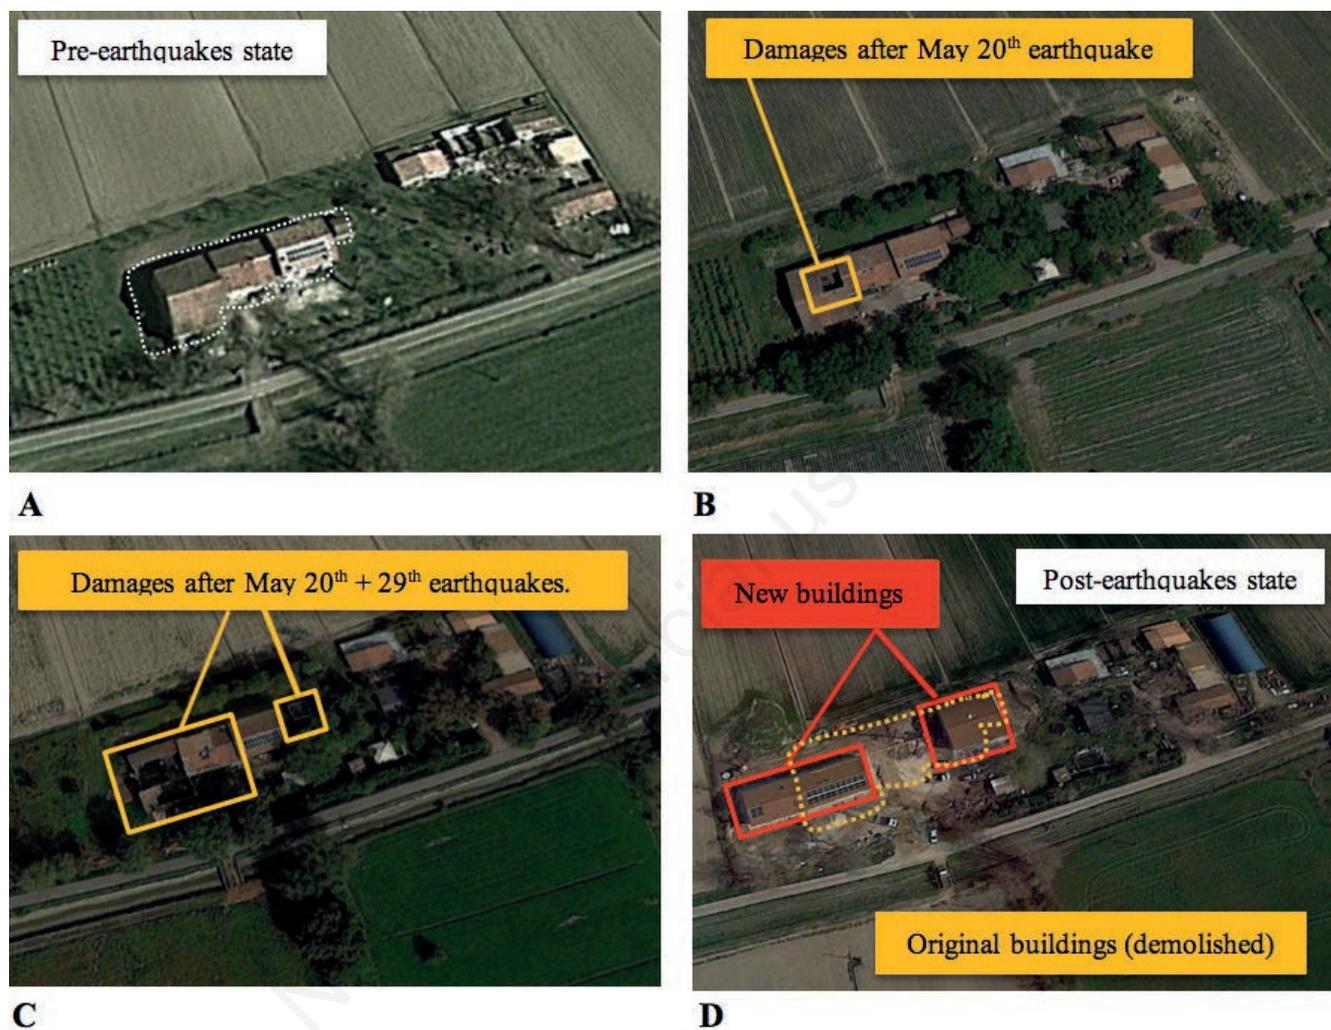
As a worrisome warning, Figure 1 shows an example of the consequences of the seismic events in the landscape of a rural complex in the province of Modena (in the Northern Italy). After the serious seismic damages reported, the buildings have been demolished and replaced by a modern precast reinforced concrete structure, with no attention to the surrounding landscape and to traditional rural buildings. It is unnecessary to highlight that, even though it is possible to rebuild after a catastrophe, the effects of the earthquake can be permanently visible because of the relevant change left on the rural landscape.

Figure 1. Aerial view of a rural complex in: A) 2008; B) few days after 2012 May, 20th earthquake; C) few days after 2012 May, 29th earthquake; and D) currently (2018) showing the demolition of the damaged structures and the construction of new modern buildings. The effects of the earthquake are permanently visible because of the relevant change left on the rural landscape.

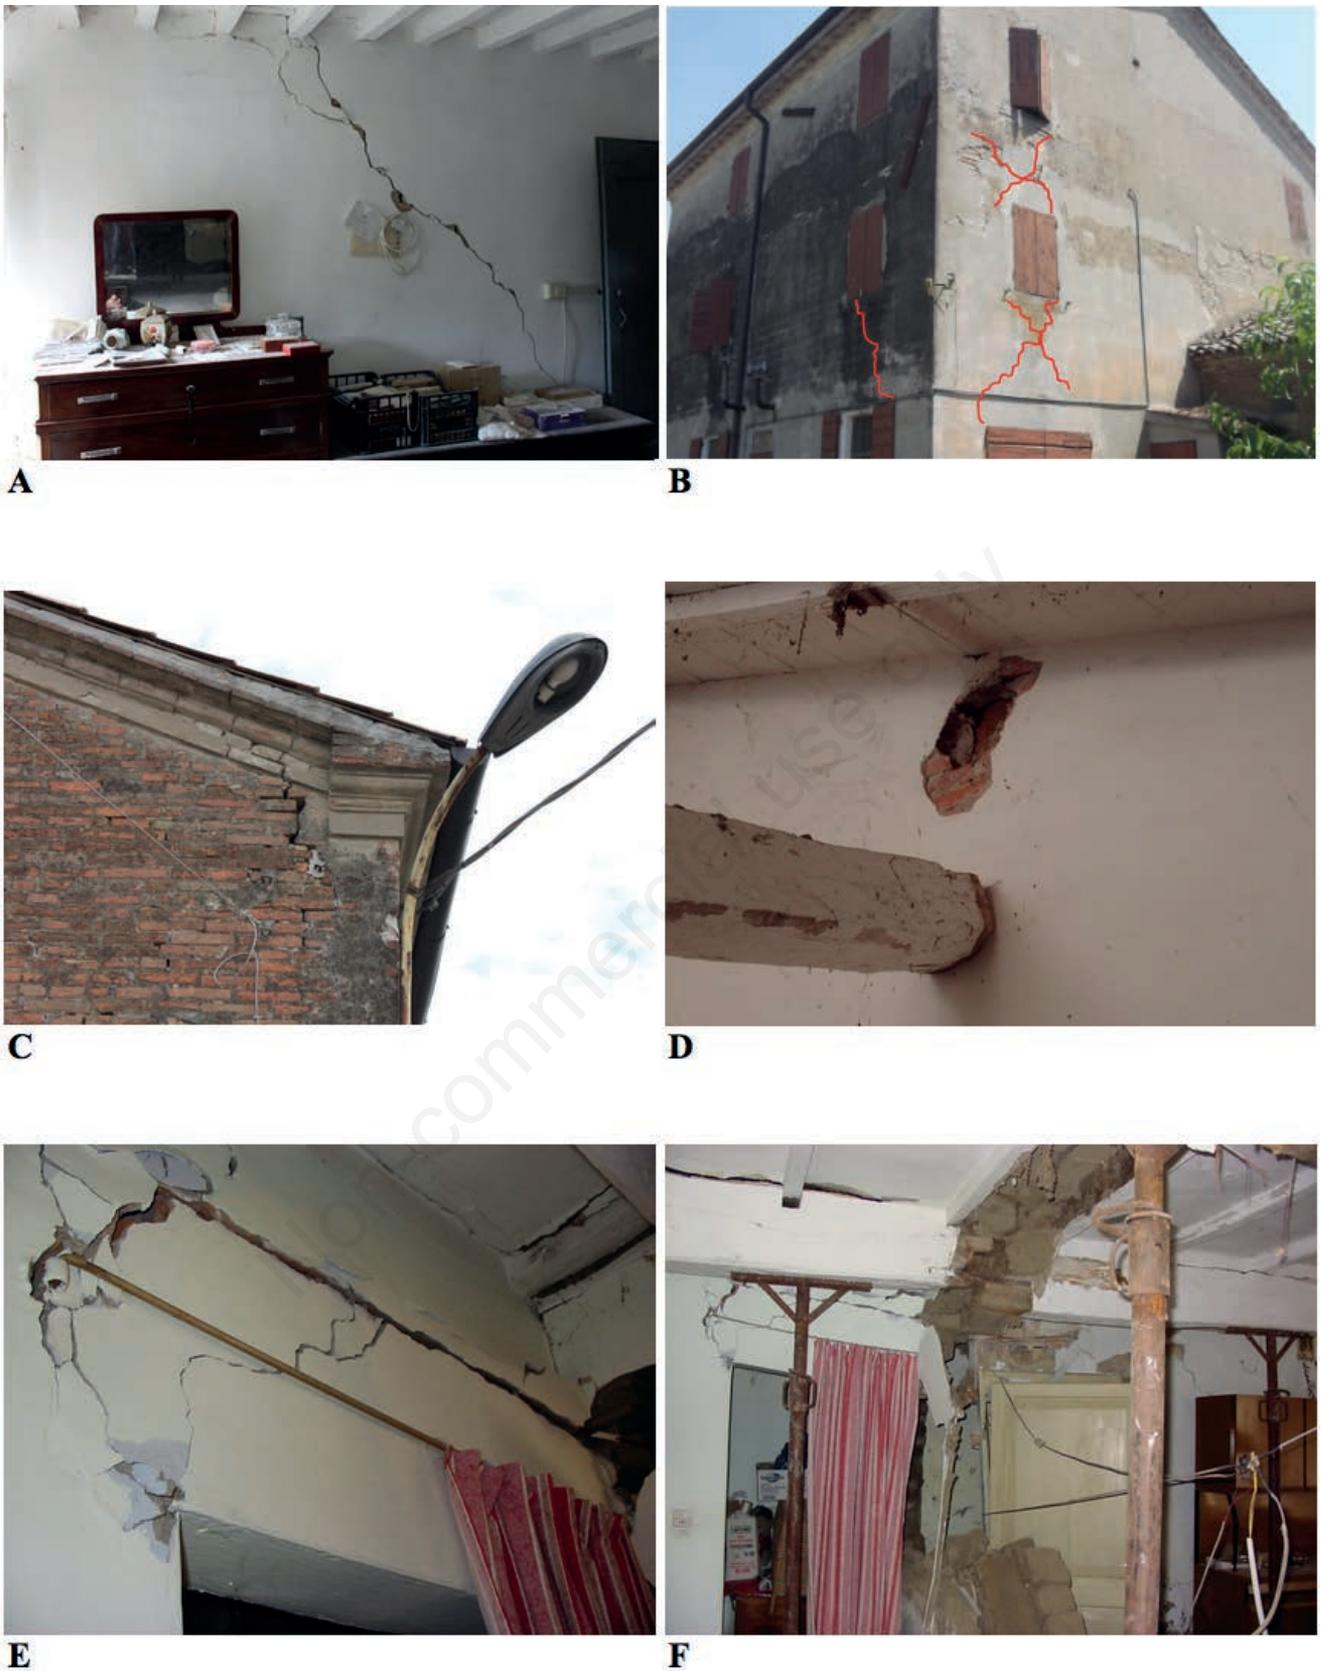
mode II failure mechanisms (*i.e.* flexure or shear mechanism in the plane of the wall) to perimeter and partition walls as depicted in Figure 4A and B. Due to limited in-plane dimensions compared to thickness, the mode I failure mechanisms usually did not appear, even if the connections between orthogonal walls are very poor, as showed in Figure 4C.

Moreover, the floor-wall connection is rather lacking: in many cases, the sliding of the beams from the masonry (Figure 3B) or even the failure was observed, due to loss of support, as documented in Figure 4D. In few cases, also failure of lintels (Figure 4E) or masonry arches (Figure 4F) typically involving permanent settlements to the horizontal structures of the floors occurred.

Figure 4. Main damages to building category A1. Example of in-plane damages induced by seismic force on: A) partition walls (bldg. #2); and B) structural walls (bldg. #6); C) cracking of corner between two orthogonal masonry walls (bldg. #1); D) loss of support of a wood beams from the masonry panels (bldg. #2); E) view of a lintel failed; and F) arch collapse (bldg. #20).

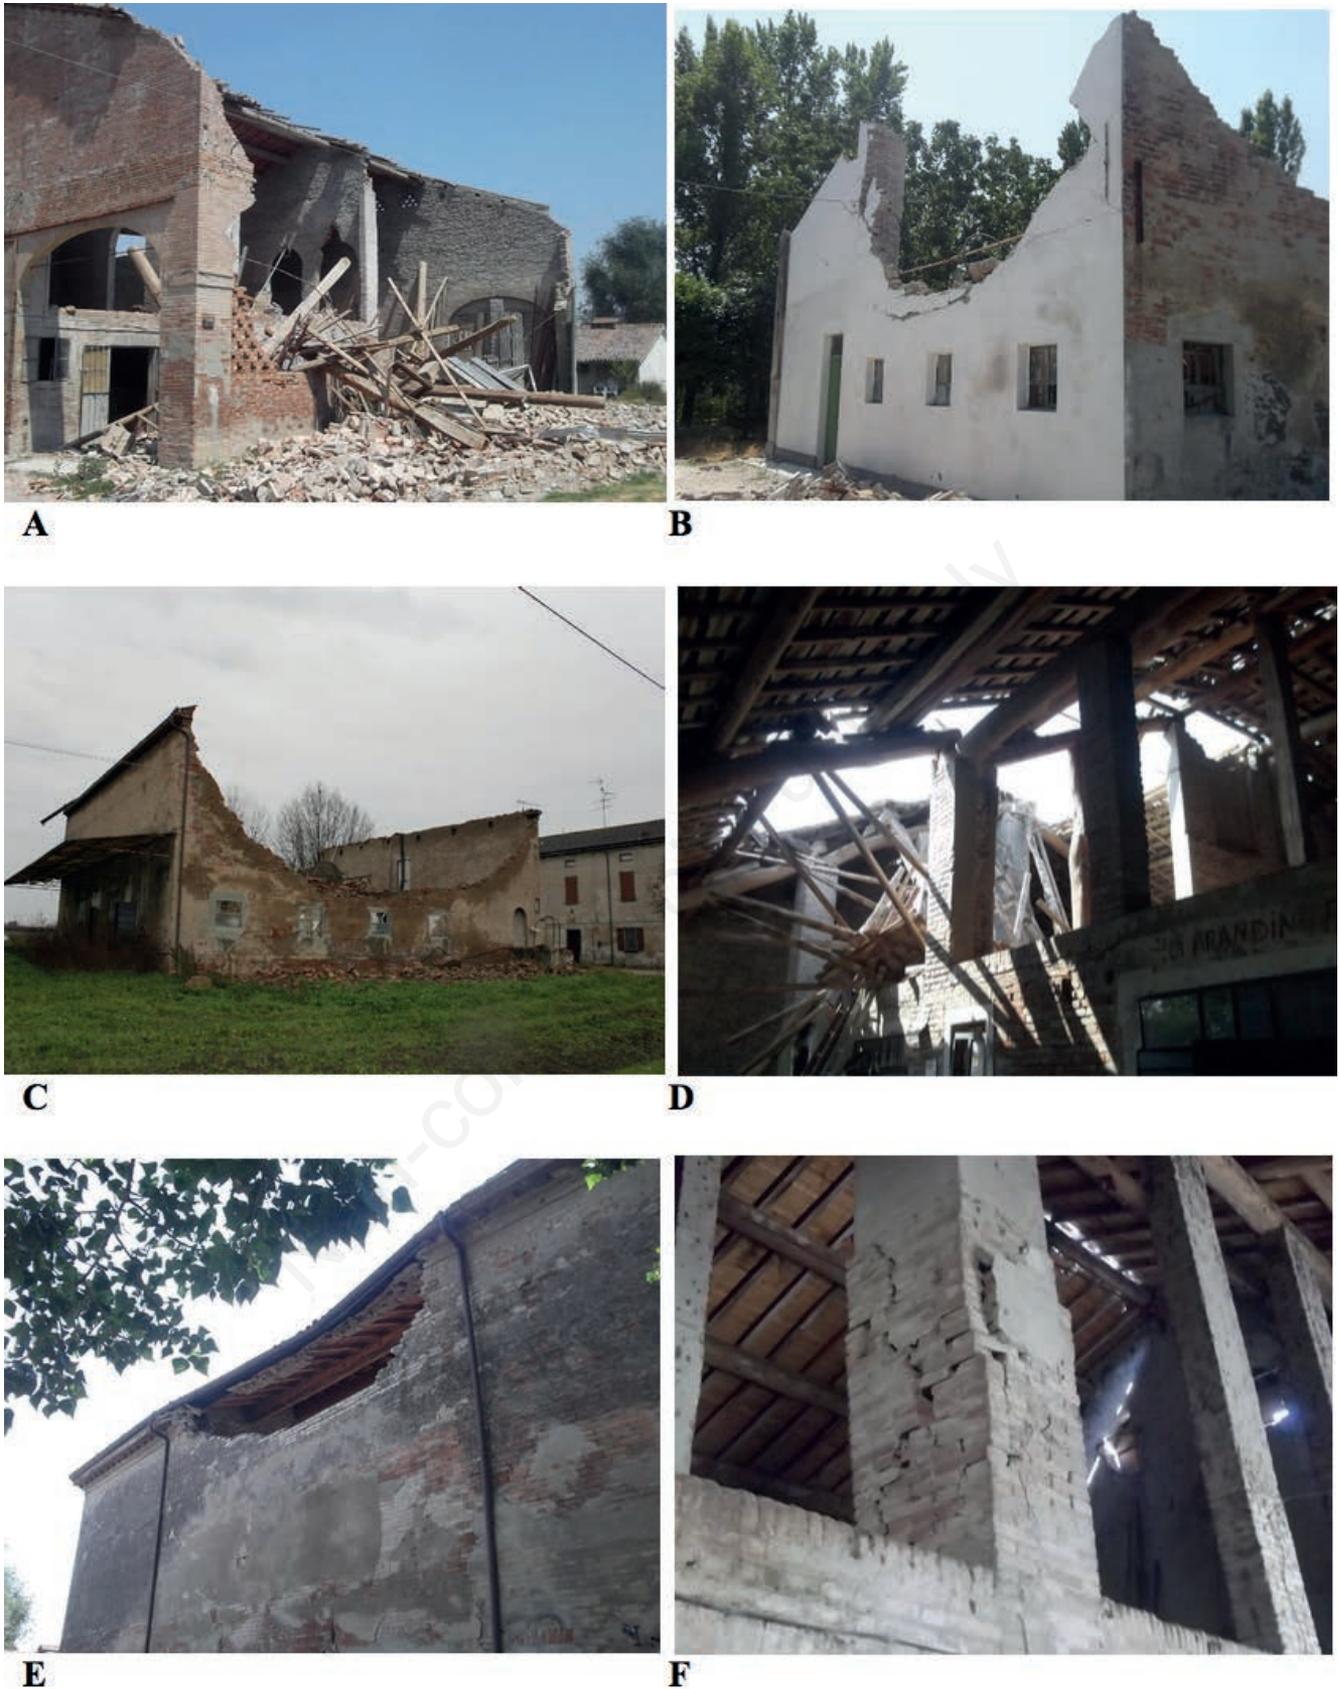
Due to the high slenderness of vertical walls and columns (the ratio height/thickness could reach values bigger than 20) and because of the distance between the masonry walls, in general the structure is expected to be horizontally very flexible, so large displacements are expected under seismic actions. In fact, the main causes of stable-haylofts collapses can be ascribed to overturning of walls, vertical and horizontal out-of-plane flexure mechanisms. A catastrophic example of collapse for overturning is reported in Figure 5A, involving a whole façade of the buildings from foundation to roof. A similar scenario is showed in Figure 5B, but in this case the out-of-plane flexure collapse anticipated the overturning façade because of the presence of a series of steel ties. Figure 5C shows the global collapse of another historical rural stable-hayloft for horizontal flexure local mechanisms. As the distance from the epicentre region increases, it can be diffusely observed that vertical walls did not collapse, but the buildings reported severe damage to roof elements and in some cases the fall of the main wooden beams. This can probably be attributed to beam-wall relative displacement causing unseating and loss of support of horizontal elements. In fact, due to the building asymmetry introduced for example by non-regular infills, non-symmetric walls (Shariq *et al.*, 2008), presence of portico and stable, two different vertical elements could vibrate in asynchronous way, by imposing at the extremities of horizontal beams, tensile force bigger than friction force and able to activate the sliding mechanism. Figure 5D shows this situation, with pitched-roof collapsed without any apparent damaging to vertical elements.

As already detected during aftermath surveys on historical cultural masonry buildings (Lagomarsino, 2006), the unrestrained forces of the beams of a deformable pitched-roof, excited by the ground motion component in the plane of the beams, can cause the overturning of a limited portion of masonry panels close to the roof. This local damage mechanism, typical of historical churches (Lagomarsino, 2012), has been detected in few cases also for historical stable-hayloft, as depicted for instance in Figure 5E. In some cases (one of them is reported in Figure 5F) the slender columns bearing the hayloft roof reported severe damage conditions at their base (*i.e.* the roof of the stable), because the horizontal seismic displacements at the building roof imposed a considerable curvature at the base-section where they are clamped.

The principal causes of collapse of this building category must be ascribed to the high slenderness of the vertical walls or columns coupled to the absence of a rigid floor diaphragm able to prevent the relative settlements between different vertical elements and to avoid the sliding of roof beams from their seat. In some cases, the presence of steel ties avoided the overturning of the walls, but these devices were not sufficient to prevent the catastrophic scenario described above.

Figure 5. Main damages to building group A2. Example of catastrophic stable-hayloft collapses for: A) overturning of the façade (bldg. #1); B) out-of-plane vertical flexure (bldg. #18); and C) horizontal flexure mechanism (bldg. #10). D) Loss of support of the roof beams for the excessive deformations of the building (bldg. #4). E) Overturning of a limited portion of masonry panels for the horizontal force transmitted by the beam elements of a flexible roof (bldg. #1). F) Severe damage at the base of a slender masonry column (bldg. #4).

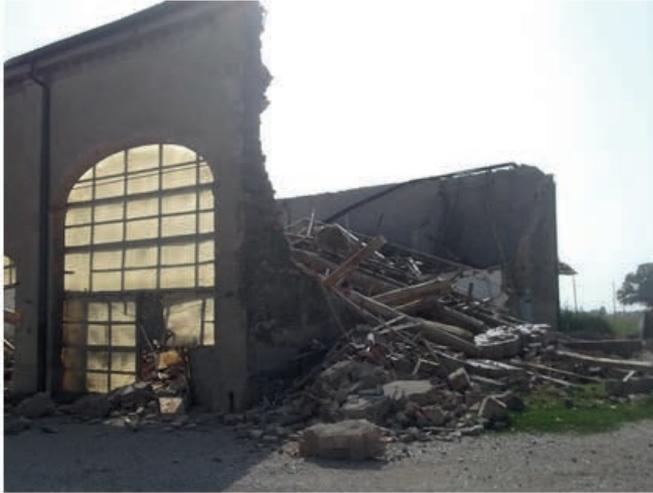
The category A3, according to nomenclature adopted in the present paper, collects the *barchessa* and *casella* structures, even though a limited number of archetypes are nowadays present in the Emilia territory. In fact, in several cases, the original layout has been modified or enlarged in the years, while in other cases the ancient building has been demolished and replaced with a more modern structure. A couple of historical buildings in the A3 group have been detected during the in-situ surveys. The *casella* (building #11 in Table 2) and the *barchessa* (building #22) are showed in Figure 6A-D as they appeared a few days after the 29 May earthquake. Similar to some stable-haylofts of category A2, because of large slenderness of vertical walls in absence of a rigid floor diaphragm, in the *barchessa* building the out-of-plane flexure

Figure 6. Main damages to category A3 and A4. A) Collapse of a *barchessa* building (bldg. #22); B) Lateral view of a *casella* (bldg. #11) with particulars of severe damages to: C) masonry columns due to excessive shear force; and D) infill walls for detachment from the structural columns. E) Structure collapse with loss of support of the roof structures (bldg. #21); and F) overturning of masonry infill walls due to the erroneous arrangement of the bricks (bldg. #17).

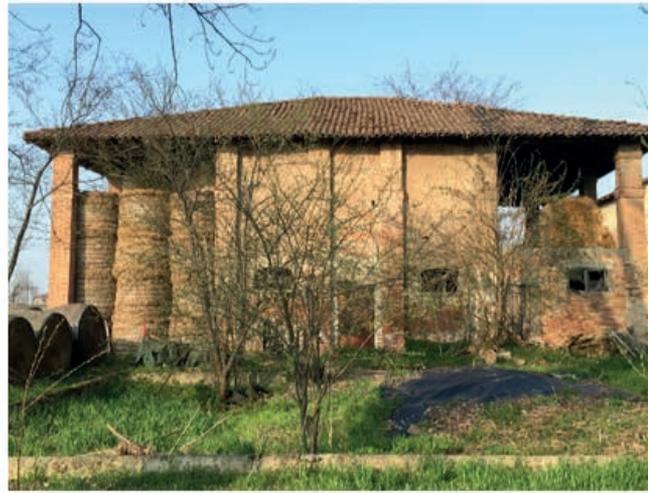
B

mechanism of a wall produced the complete collapse of the roof. Instead, in the years, the original *casella* has been modified since the transverse sides were infilled by masonry walls poorly connected to original corner columns and an intermediate floor has been introduced. Figure 6B shows the most important seismic induced damages to the columns caused by the asymmetric behaviour of the building. Due to the torsion effects, the corner columns were literally cut at the level of the intermediate floor, as proved by the residual settlements highlighted in Figure 6C. Furthermore, the presence of poor column-infill wall connections produced the detachment of the walls during the seismic events (Figure 6D). The structures have been demolished a few months after the earthquake. As already stated in previous section, the authors had information only on two buildings in this category. Due to the reduced samples in the category A3, the damage mechanisms could not completely representative of the whole category. Anyway, Sorrentino *et al.* (2014) reported in a detailed way the damages they observed during post-earthquake in-field surveys on three *caselle* (located in the Province of Modena or Province of Reggio-Emilia). By the comparison between the buildings in Sorrentino *et al.* (2014) and the A3 buildings of the present paper stock, it emerges that main dimensions, materials and construction techniques result very similar and the buildings exhibit same damage/collapse mechanisms. This could represent a first proof of the validity of the outcomes discussed here concerning the collapse mechanisms of building category A3.

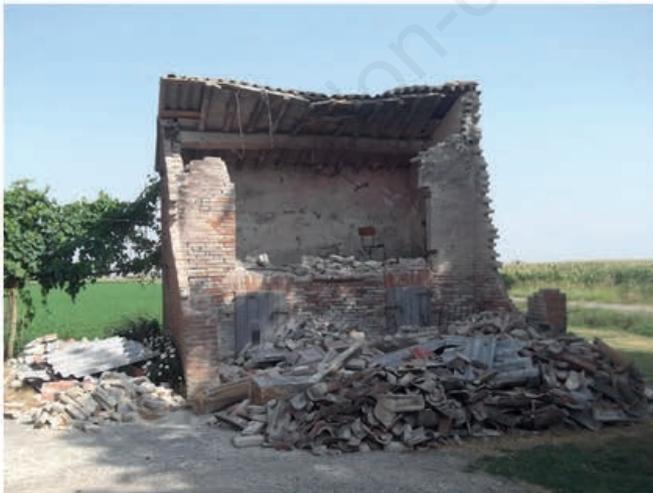
E

The typical damages to building category A4 are very similar to those observed for residential rural buildings of group A1, due to comparable geometries, but they are magnified because of the poorer materials and construction techniques. In fact, as depicted for example in Figure 6E with regard to warehouse #14, the collapse of the floor of roof elements is one of the most recurring mechanisms, together with the in-plane failure of walls. Then, in many cases, the overturning of the infill panels not adequately connected to vertical masonry columns was observed. An example is reported in Figure 6F, showing a specific case of masonry infills collapse, where the bricks closing off the original openings have been laid in their own plane creating a panel extremely vulnerable to out-of-plane actions.

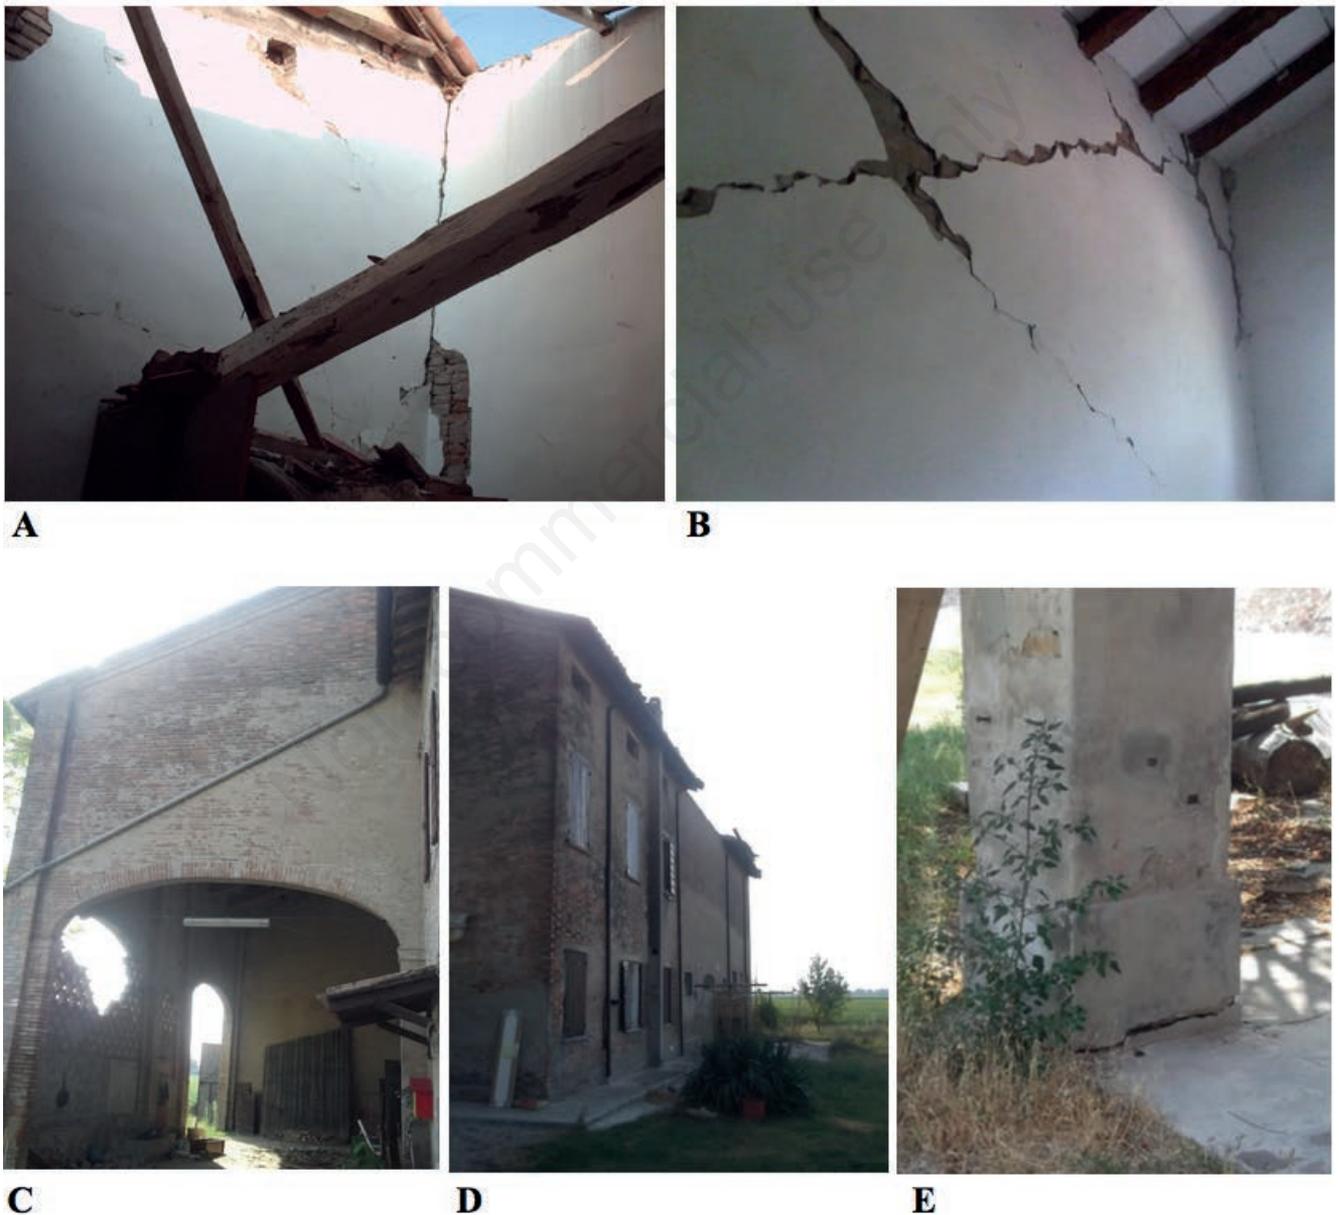
ure or fall of these elements do not cause the collapse of the building, however they can represent a serious risk for people inside or close to the building. In Figure 7C and d two typical examples are showed. The first is related to the failure of non-structural ornamental elements like the *gelosie* (Figure 7C), typical holed infill walls widespread in northern Italy. The second refers to perimeter masonry cornice (Figure 7D) typically built with external good texture masonry and internally infilled by waste material and so with poor mechanical strength. These elements often represent the only building friezes, since the vernacular context usually is governed by simplicity. Lastly, as stated upon, in rural buildings it is quite common to find porticos and wooden sheds commonly sup-

Figure 7. Particular of damages to category B buildings and non-structural elements. A) Fallen of timber roof beams from the intermediate wall in a composed building # 8. B) Corner opening between orthogonal walls poorly connected (bldg. #8). C) Failure of *gelosie*, typical holed infill walls (bldg. #5). D) Fallen of a portion of the perimeter masonry cornice (bldg. #5). E) Cracking at the base of a masonry column portico (bldg. #7).

ported by thin masonry pillars. These columns, during the seismic events, displayed some damages because of their inability to overcome large horizontal displacements. A typical crack pattern of the base portion is showed in Figure 7E. It is evident that the column base-section results partially working because detached by the foundation plinth.
