Terraced landscapes: risk and liability

Keywords: Agricultural terraces, Amalfi coast, liability, property renunciation, risk, terraced landscape

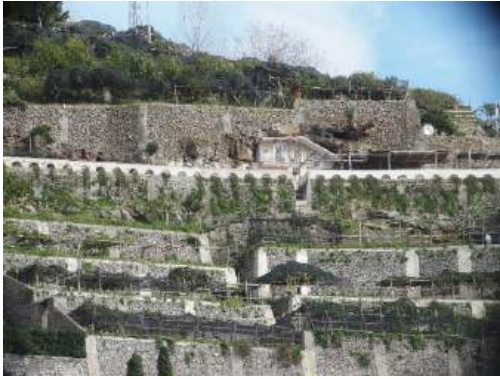
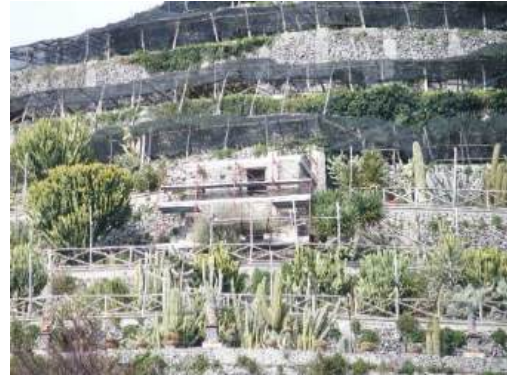
Figure 7. (a) and (b) New buildings camouflaged among the terraces. Photo provided by the authors.

Figure 7, Figure 8 and Figure 9 show how landslide risk in the event of terrace failure is perceptible to an ordinary observer. The ongoing building activity, although not very perceptible, is still present, considering that the value of the properties generally exceeds 5,000 €/m².

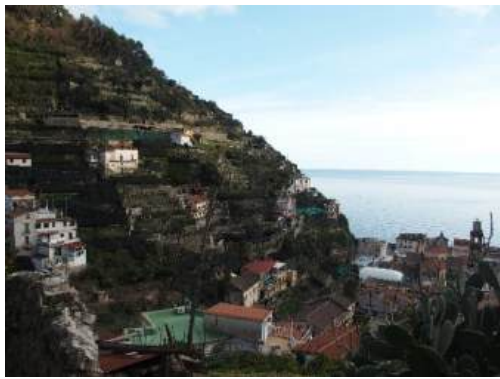
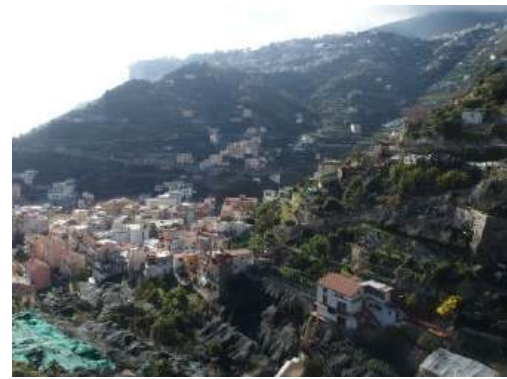
Figure 8. (a) and (b) The mix of houses and terraces. Photo provided by the authors.

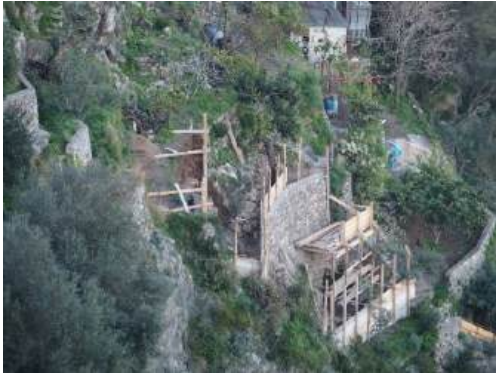
Figure 9. (a) Reconstruction of retaining walls using traditional techniques; (b) The collapse of the retaining walls shows the construction techniques. Photo provided by the authors.
