Terraced landscapes: risk and liability

Gabriele Delogu,¹ Lorenzo Boccia,² Giuseppina Mari²

Abstract

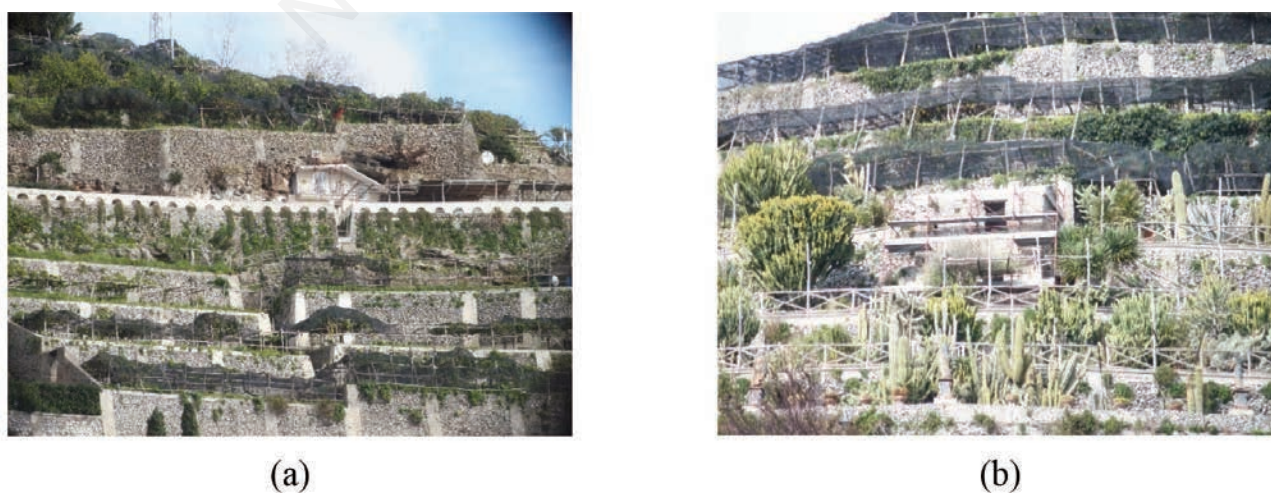
Figure 7. New buildings camouflaged among the terraces. Images provided by the authors.

Figures 7 to 9 show how landslide risk in the event of terrace failure is perceptible to an ordinary observer. The ongoing building activity, although not very perceptible, is still present, considering that the value of the properties generally exceeds 5,000 €/m².

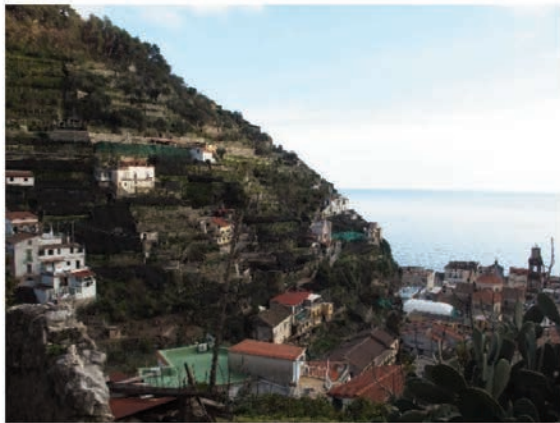
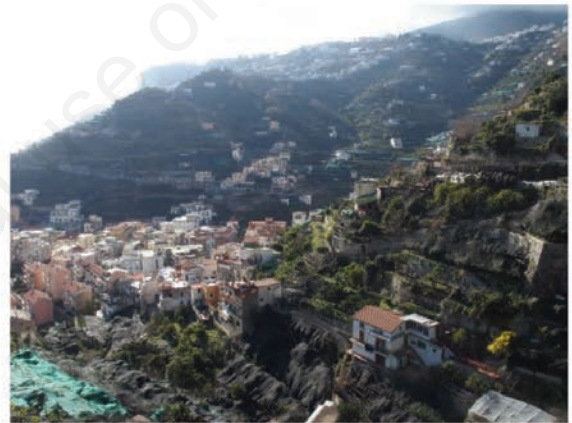
Figure 8. The mix of houses and terraces. Images provided by the authors.

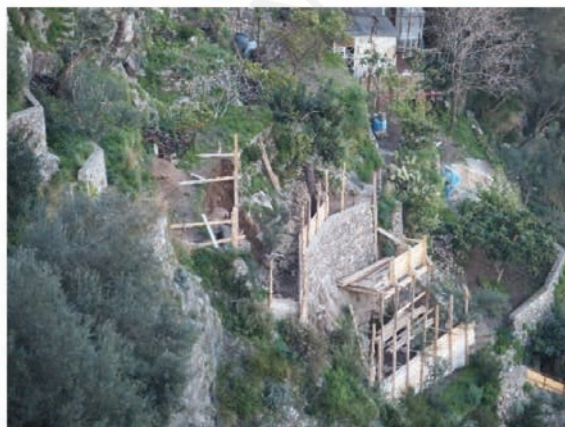
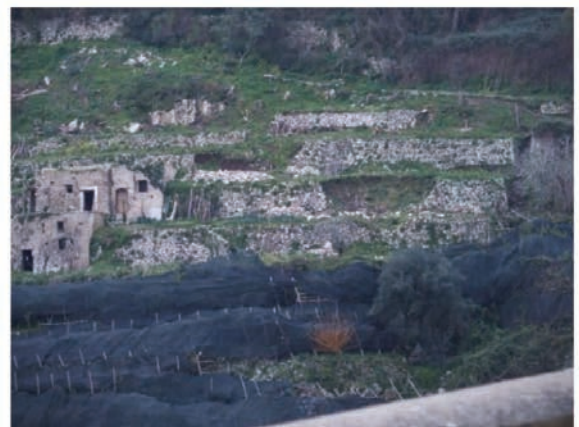
Figure 9. a) Reconstruction of retaining walls using traditional techniques. b) The collapse of the retaining walls shows the construction techniques. Images provided by the authors.

supports each terracing is drywall, which has a height of between 2 and 5 m. Historically, many walls were originally built with reduced heights, and, with the continuous formation of sediments upstream, they were raised up to their current conformation, with a typically rectangular wall section with approximately vertical faces.

retaining wall. The collapsed sections, shown in Figure 9b, have wall thicknesses of the order of 50 cm.
