# Static consolidation of a renaissance palace by resins, pins and connecting rods

## Abstract

Key words: historical building restoration; anchoring means; static consolidation.

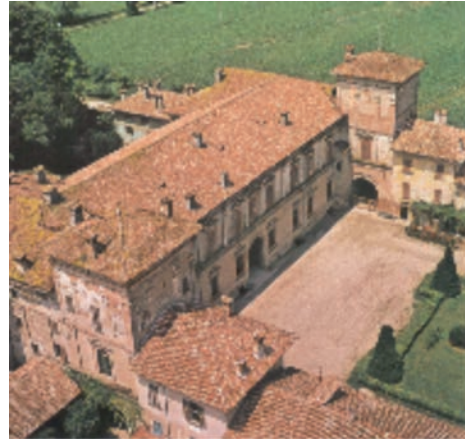
Figure 1. General view of Branduzzo palace.

The Branduzzo complex is completely built with terracotta bricks produced locally. It is made up of two rectangular courts having a common quarter, of which one smaller so called noble, and one larger used for agricultural purposes. The former is closed on three sides by two-storey buildings; the fourth side overlooks the Bramante palace. Four towers in the court corners complete the court. Of these the two shortest ones joint the three short bodies and are extremely simple, they date back to the middle of the 400s, while the two that joint the body of the palace are decidedly taller and stylistically homogenous with the same palace (Figures 1 and 2).

As for the one facing north (Figure 1), poor upkeep, structural modifications in the XVIII c., and time itself have caused severe settling. The object of this paper is in fact static consolidation.

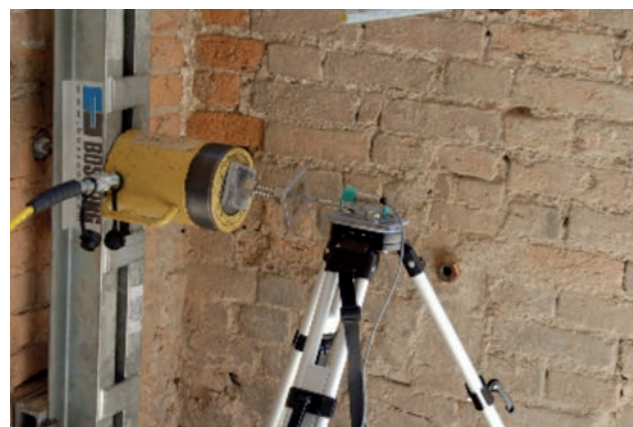
Figure 6. The equipment during the extraction trials.

Once the perforations were made using a core boring machine, the steel bars were have been anchored with binders using the procedure indicated in table 1. Time was allowed for the mortar and resin to dry; subsequently extraction trials were carried out using a manually activated pierced piston oleodynamic cylinder extractor able to exert a maximum force of 576 kN, measured by means of a pressure transducer applied to the hydraulic circuit. In relation to the applied load, movements were measured using a straight transducer potentiometer with a ball-like sounder having a resolution of 0.01 mm positioned on top of the steel bar. To read and record test data, an acquisition digital system, made up of a personal computer linked to an acquisition/conversion A/D (anologic/digital) electronic control unit, was used. Recording of instrument indications (load or pressure and movement) was carried out every 0.5 seconds. Figure 5 shows an outline of the trial equipment used.

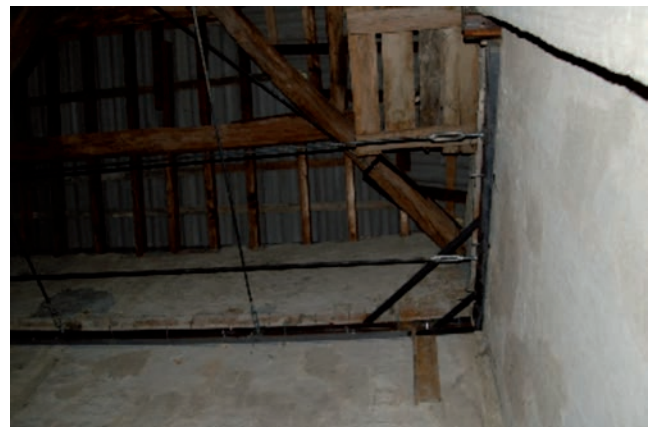
Figure 9. The loop created from inside: the U profile fastened to the masonry by the anchored pins, the triangular frame at the corner and the steel tie rods are shown.

hoop a UPN 120 profile was chosen easy to place, perforate and capable of following the curvilinear profile of the brickwork, while guaranteeing good resistance to flexion in terms of y (Wy=11,1cm<sup>3</sup>). The section was fastened to the walls with 14 pins 12 mm (wall holes 14 – ideal anchorage length 350.mm) using epoxy. Wheel-base between the pins is variable to avoid the perforations from falling in the joints between the single bricks, is circa 50 cm. Then, by a series of steel tie rods it was possible to tie the opposite walls . Finally, triangular frames have been positioned on the 4 corners in order to avoid teething collapse in case of great stress (Figure 9). Cautiously taking into consideration a load of 10kN/pin determined by using a safety coefficient=4, the system should be able to resist lateral thrusts of 140kN

connection of the profile, the method used makes it possible to build an efficient containment of the tower walls, in order to create the box-shaped structure and efficacy of the walls to support horizontal thrusts that may occur during earthquakes. The metal elements bond the walls stressed orthogonally on its floor, impeding overturning.
