Report on earthquake-induced failures of rural buildings aimed at future preservation strategies

Marco Bovo, Alberto Barbaresi, Daniele Torreggiani, Patrizia Tassinari

Department of Agricultural and Food Sciences, University of Bologna, Italy

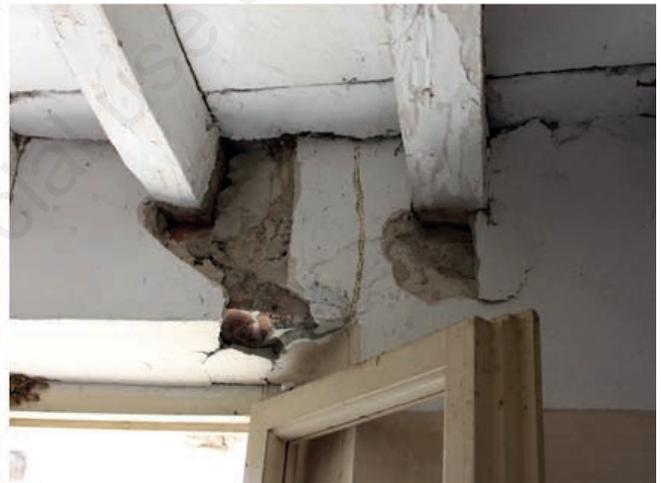
B

Figure 3. Particulars on materials and construction techniques of historical rural buildings. A) Masonry wall texture. B) Structure of a wooden floor; C) Cane panels protecting timber beams. D) Vaulted masonry floor.

Moreover, the floor-wall connection is rather lacking: in many cases, the sliding of the beams from the masonry (Figure 3B) or even the failure was observed, due to loss of support, as documented in Figure 4D. In few cases, also failure of lintels (Figure 4E) or masonry arches (Figure 4F) typically involving permanent settlements to the horizontal structures of the floors occurred.
