# The influence of management and construction methods in the repair costs of Spain's low-volume road network

This paper describes the entire process of the implementation of the Spanish low volume road network, including the design criteria, the construction techniques and the management policies during all the periods. The current situation of low volume roads in Spain was analysed with respect to the legal framework and their actual condition. In addition, the budget required for the repair of 41 low volume roads throughout Spain was calculated in order to statistically analyse the influence of the pavement materials and the period of construction. The main conclusions were that low volume roads constructed during the 1970's are currently those in the best state of repair and those requiring the lower repair costs, even lower than those constructed after 1980's. In addition, low volume roads constructed with higher quality materials and using standardised techniques required five times lower repair costs than those made of lower quality materials.

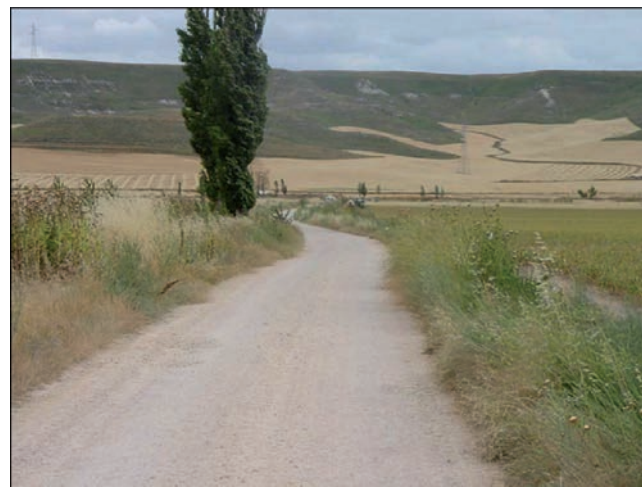
Figure 3. Low volume road paved with macadam.

The most common pavement used during this era consisted on a single base layer of macadam (Figure 3). This material consists of fractured stones 6-8 mm in diameter, which are later compacted and the spaces are filled with sand. If macadam was laid over a clayed substrate, then a granular subbase layer had to be laid below the macadam base. This kind of pavement is suitable for low traffic loads and its durability is good. Thus, the low volume roads built during this era remained in good condition for many years. At the end of this era the use of stabilised granular materials became more common, especially in irrigated areas.

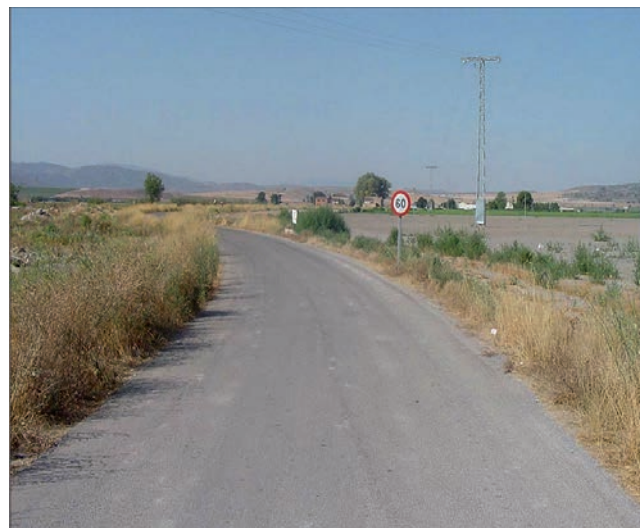
Figure 4. Low volume road paved with a double surface treatment.

The percentage with an asphalt cover grew rapidly over this era; indeed, in many areas nearly all the low volume roads laid during this period were provided an asphalt surface. This asphalt surface is generally rather than, about 3-6 cm. Sometimes this asphalt is pre-mixed, but it was quite usual to place a surface treatment. A film of binder is laid on the road and then a layer of small uniform chippings is laid immediately over it. This process may be performed only once, but it is more usual to perform it twice (Figure 4) or even three times.

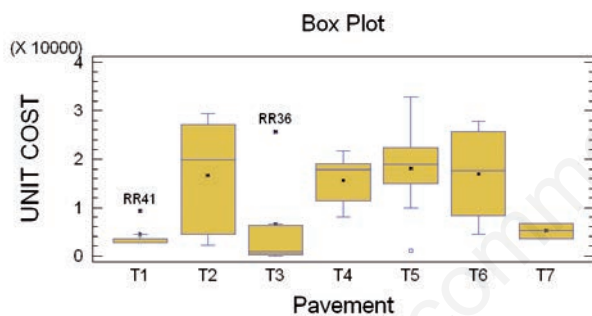
Figure 5. Box plots representing the costs of repairing low volume roads (€ km<sup>-1</sup>) according to their construction type.

In the statistical analysis taking into account the construction type (Figure 5), low volume road RR41 was excluded due to its high cost of repair per unit length compared to the other roads in category T1 (*i.e.*, with an asphalt top). For the same reason RR36 was excluded; its repair costs were atypical for the T3 category (granular surface).

Statistical analysis of the repair costs for the remaining roads provided the results shown in Table 5. For this study, RR36 and RR41 were found to be atypical values, and therefore they were excluded since their repair costs were too high if compared with those obtained for the remaining low volume roads included within their same category (T3 and T1, respectively). Some construction types, such as T1, T3 and T7 (range 3000-5000 € km<sup>-1</sup>) were found to have much lower repair costs than the others, which all reached mean values of over 15,000 € km<sup>-1</sup>. From this study it could be checked that repairing costs for T1 were almost five times higher than those for T2. The use of artificial stabilised granular materials increase the construction costs with respect to those obtained when using natural stabilised granular materials. On
